RAILWAY INVESTIGATION REPORT

R01M0061

CROSSING ACCIDENT AND DERAILMENT

CANADIAN NATIONAL

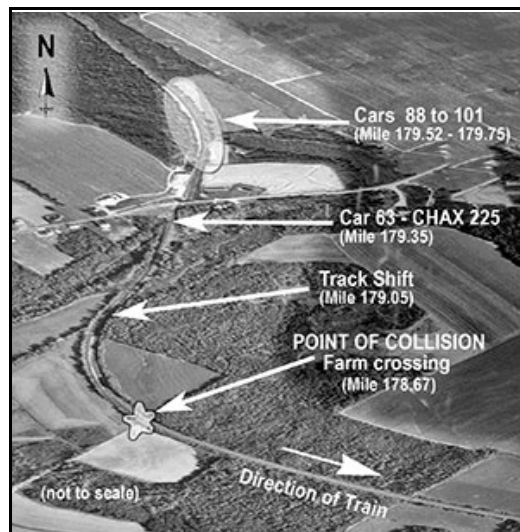
A subsequent inspection of train 306 determined that the 63rd car, and the 88th car to the 101st car from the head-end, derailed (see Photo 1). Fresh marks were visible on striker castings and coupler horns on many cars throughout the train.

Photo 1. Aerial photo of accident site
(Source: Natural Resources Canada)

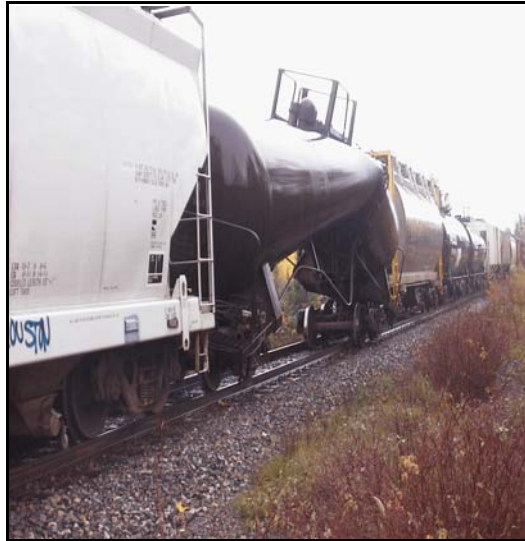
The 63rd car, CHAX 225, a class 111A tank car, buckled upwards and derailed the B-end⁴ at Mile 179.35 (see Photo 2). The tank car was empty and located between loaded hopper cars. Samples from the car were sent to the TSB Engineering Laboratory for analysis (report LP 102/01); the examination did not reveal any significant reduction in the car's strength. According to Association of American Railroads (AAR) design standards, tank cars must withstand a minimum longitudinal force of 1 000 000 pounds.⁵

Photo 2. Damaged tank car CHAX 225

For instance, train 306 was a long train marshalled with most of the weight in the tail-end. At the time of the accident, train 306 was negotiating an ascending grade, and was, therefore, fully-stretched; as the emergency brake was applied from the locomotive, a run-in occurred, and high buff forces were generated. Although the track met CN's *Standard Practice Circulars* and TC's *Railway Track Safety Rules*, the action of the buff forces on the 88th to the 101st cars, where several long/long, long/short car combinations were located on curved track, generated high lateral forces that exceeded the resistance of the track structure, causing gauge widening, rail rollover, and the derailment of the cars. Furthermore, the buff forces generated compressive stresses that exceeded the design specifications of the 63rd car, an empty tank car located between loaded cars, causing the tank car to derail and buckle.

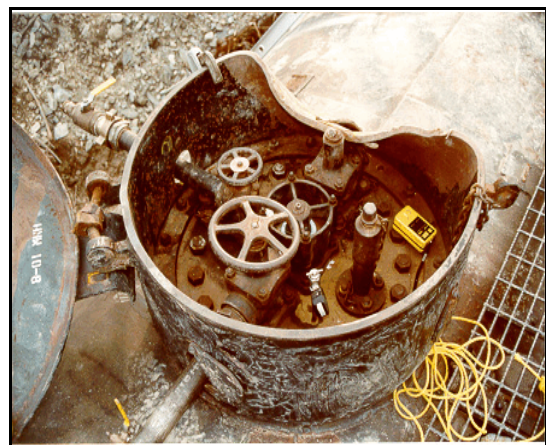
The 95th car, CITX 4240, a class 112 pressure tank car, came to rest on its side, striking the underframe of the 94th car. The protective housing was bent, damaging the liquid education valve (see Photo 3) and causing a release of butane.

Photo 3. Damaged top fitting housing of car CITX 4240

In this occurrence, the liquid eduction valve was damaged, causing product to leak when tank car CITX 4240 overturned while train 306 was travelling at 27 mph. This type of damage also occurs in yard accidents where the speed is relatively low, as was observed on tank cars involved in the yard derailments at Macmillan Yard and Red Deer (TSB Report No. R98T0292 and Report No. R01E0009). Following these derailments, Transport Canada (TC) indicated that issues relating to design requirements applicable to top fitting protection would be examined when the standards were reviewed. In August 2002, new dangerous goods containment standards were issued; however, the requirement for rollover or skid protection for top fittings was not improved. Therefore, the shortcomings identified in the protection of top fittings remain unaddressed and will continue to present a risk to the public and the environment.

3. As there is no requirement for rollover or skid protection for top fittings on pressure tank cars, damage to the top protective housing and fittings will continue to occur even in accidents where the speed is relatively low.

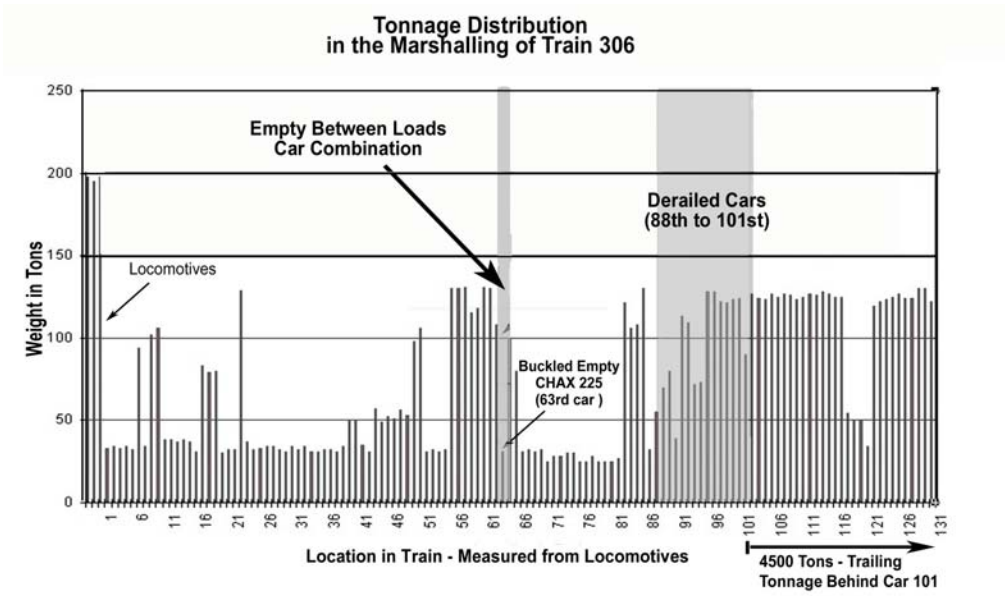
Most of the loaded cars on train 306 were located in the tail-end portion of the train (see Figure 2). There were several long-long and long-short car combinations in the consist (see Figure 3). Ten of the cars were equipped with EOCCDs. Train 306 passed by a wayside information system at Mile 200.5; no defects were noted.

Figure 2. Tonnage distribution

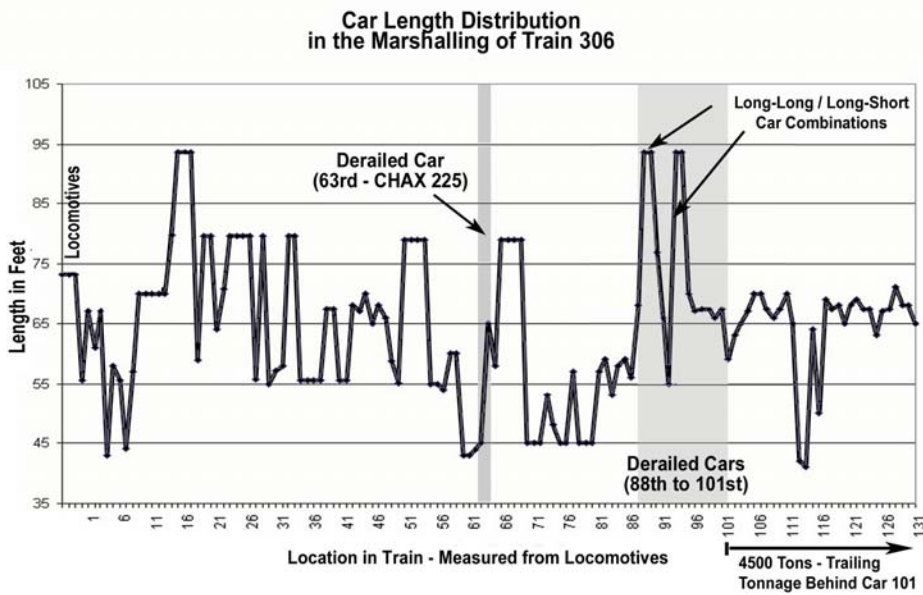
Figure 3. Car length distribution

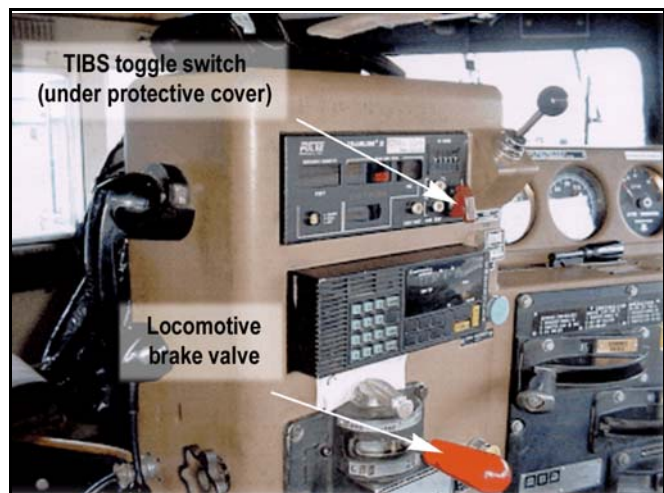
Photo 4. Locomotive control stand

Even though CN has a directive requiring locomotive engineers to initiate end-of-train braking in emergencies by actuating the toggle switch on the control stand in order to reduce in-train forces, the toggle switch was not actuated in this occurrence. During emergency brake activation, a locomotive engineer must quickly respond and perform a sequence of actions under pressure. To ensure that all motor components of the emergency procedure are reliably triggered, the response sequence must be overlearned¹⁵ (i.e., it becomes, through repetitive practice, an automatic process, thereby requiring less attention and making emergency responses more resistant to stress and interference by other tasks). If the emergency braking procedure is not overlearned, it is not performed consistently from both ends of the train, resulting in higher in-train buff forces and a greater risk of derailment.
